EVALUATION OF Liquid-Applied Waterproofing Systems:

CASE HISTORIES

By Kami Farahmandpour and Terry Willems

Case 1 - Cincinnati Museum Center Plaza Fountain

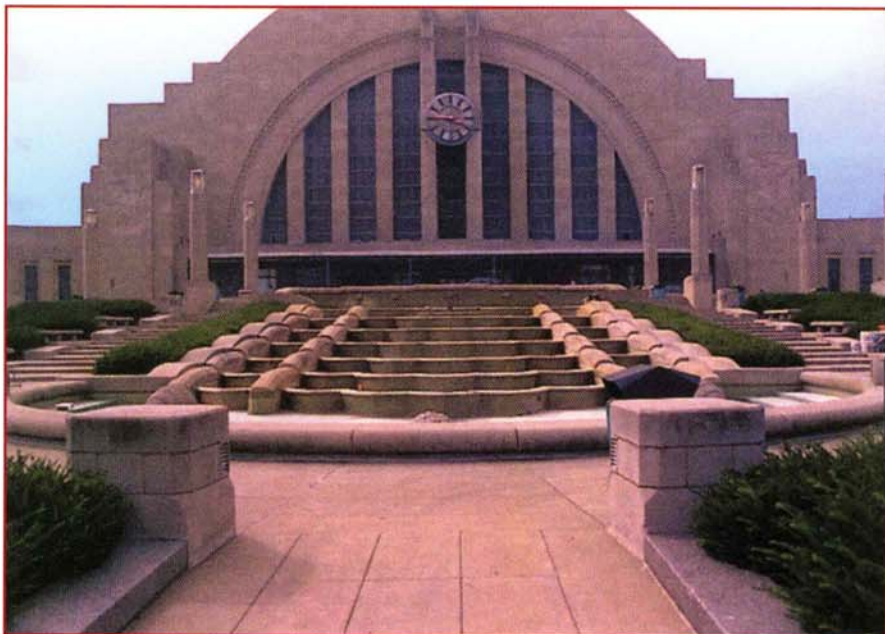
Photo 1 - Overall view of the Cincinnati Museum plaza fountain

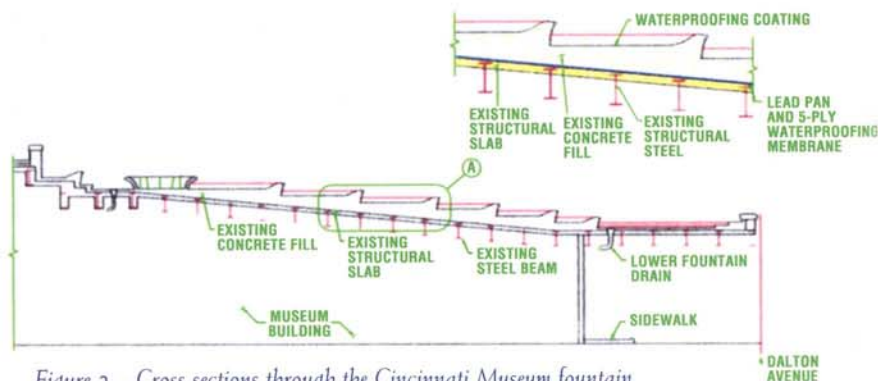
Figure 2 – Cross sections through the Cincinnati Museum fountain.

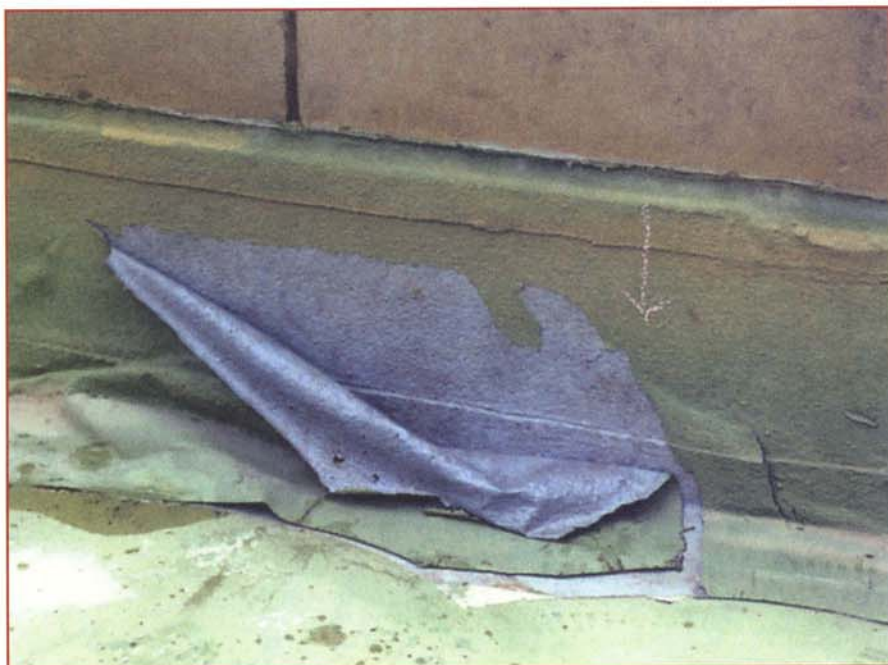
Figure 3 – Typical example of interlayer disbonding of the membrane between the green top coat and the gray base coat.

The coating had disbonded (separated from the substrate) and delaminated (separated from its underlying layers) in many areas of the fountain (Figures 3 and 4). Large sheets of membrane and color coat peeled away easily in some areas. In general, second and third applications of the

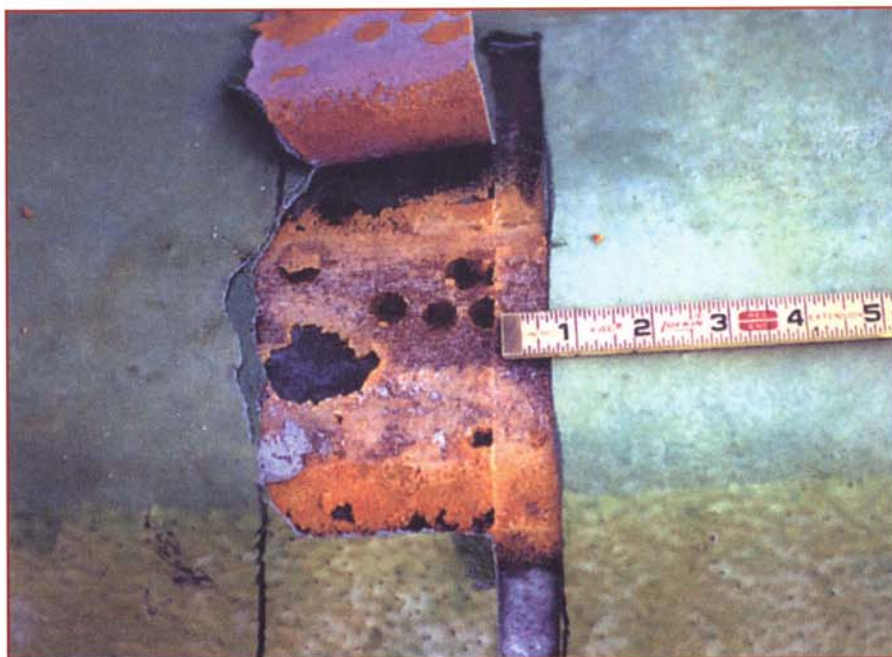
Figure 4 – Typical example of membrane disbonding from the epoxy patching material.

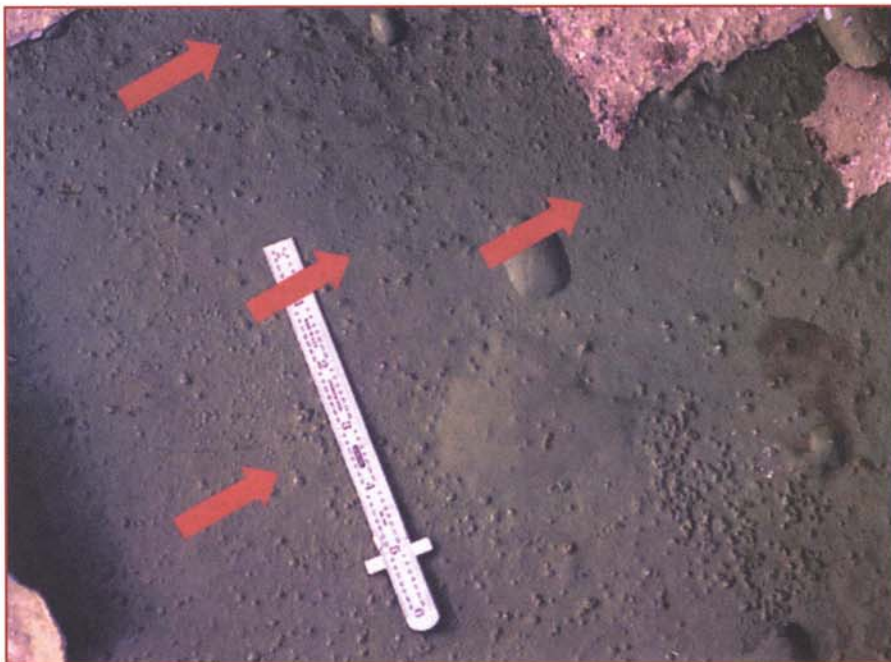
Numerous water-filled blisters, ranging in size from 1/4 inch to 4 inches in diameter, were observed (Figure 5). Several of these blisters were cut open to determine the location of the water layer within the coating system. The location of blistering varied, occurring between coats (layers) of the first application membrane, at the primer/membrane interface, at the color coat/membrane interface, or between layers of the color coat.

Figure 5 – Surface blisters in the membrane (red arrows).

Numerous small pinholes and blisters in the first application of the primer and membrane were observed. There was no record of water vapor emission tests having been performed prior to application of the liquid-applied membrane. Therefore, it was concluded that the concrete substrate was saturated and exhibited high water vapor emission rates during and immediately after application of the membrane system. This high water vapor pressure resulted in the formation of numerous pin-

holes in the primer. These pinholes provided a path for water vapor to penetrate the porous membrane from the substrate below, and fill air voids with water, producing blisters.

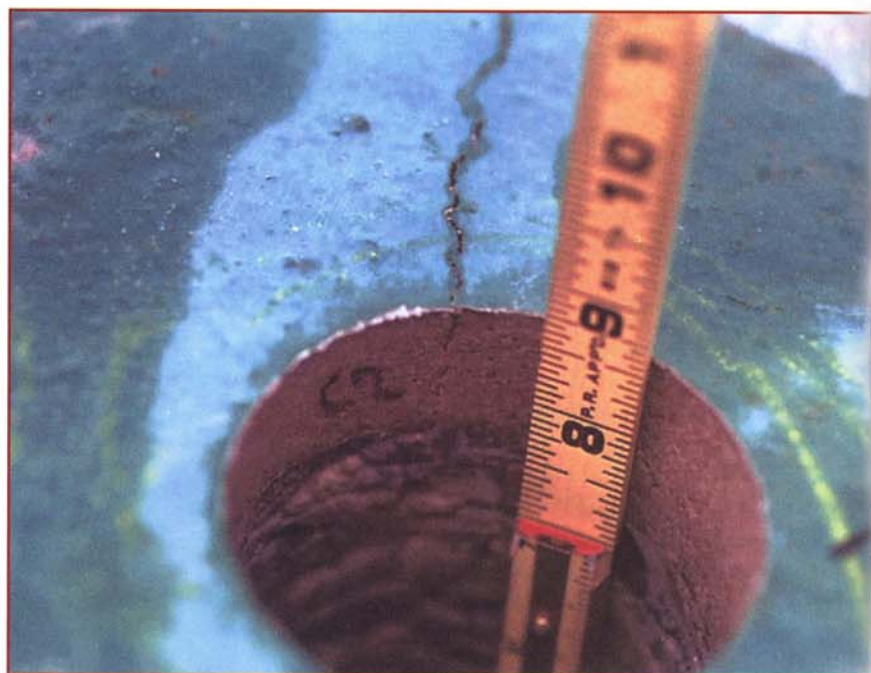
In several areas, cracking of the substrate concrete had reflected through the membrane directly over the crack (Figure 6).

Figure 6 – Substrate cracks reflecting through the membrane.

Cracks observed within the membrane lined up with cracks in the substrate. These cracks were attributed to deterioration of repair patches, as well as to cracking and deterioration of the original concrete within the fountain. Since the original fountain concrete was not air-entrained and did not have a topline waterproofing membrane for many years, it was susceptible to freeze-thaw deterioration. Also, a drainage layer was not provided at the level of the lead pan. Therefore, water penetrated and saturated the concrete above the lead pan. During winter months, the trapped water froze and cracked the saturated concrete. This deterioration likely began early after construction and had continued through the life of the fountain.

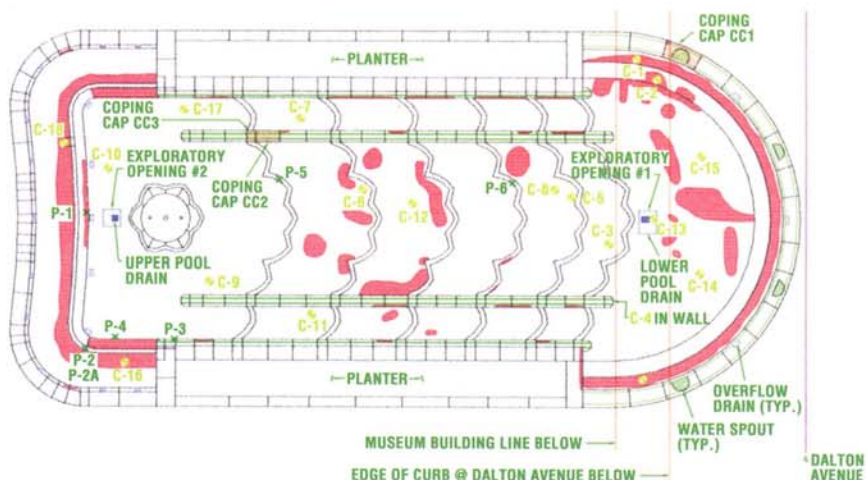
Approximately ten percent of the fountain surfaces exhibited sub-surface delaminations when sounded with a hammer (Figure 7). The delaminations were primarily in areas where previous repairs were performed using an epoxy repair mortar. Core sampling at these locations showed that the epoxy repair material had debonded from the substrate concrete.

Figure 7 – Above, delamination survey of fountain surfaces revealed significant areas of delamination concrete (red areas).

Based on the findings of this investigation, it was concluded that the only viable long-term solution for rehabilitation was a complete reconstruction of the fountain above the lead pan.

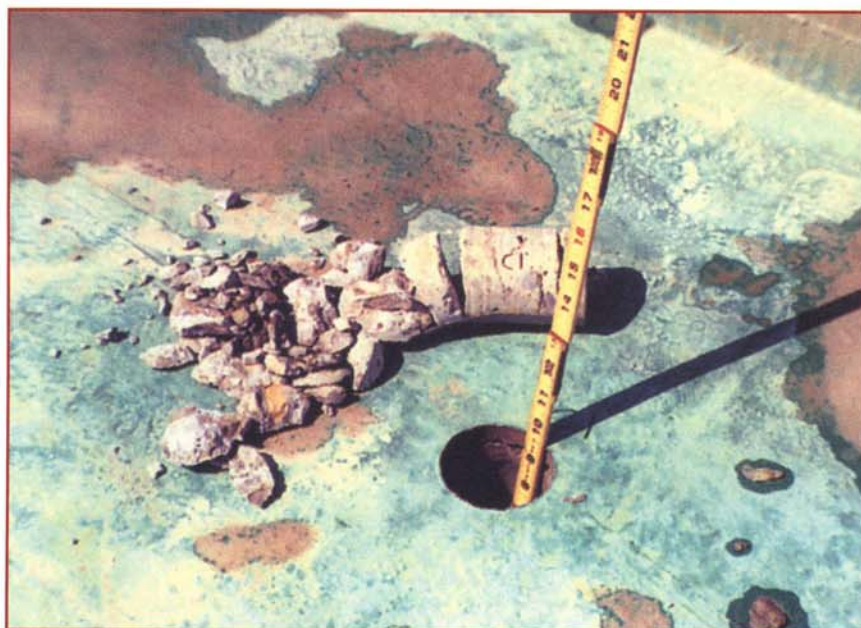
Examination of cores during sampling indicated widespread delaminations deep within the fountain concrete. Most of these areas containing deep delaminations were not detectable by hammer sounding (Figure 8).

Figure 8 – Coring of the substrate revealed extensive freeze-thaw deterioration.

In general, the epoxy repair mortar had delaminated from the cementitious substrate. The majority of the deterioration and cracking was found in the original concrete layer. The original concrete was not air-entrained. Therefore, it is susceptible to freeze-thaw damage when saturated with water. Extensive sub-

parallel cracking, typical of freeze-thaw damage, was present in the original concrete

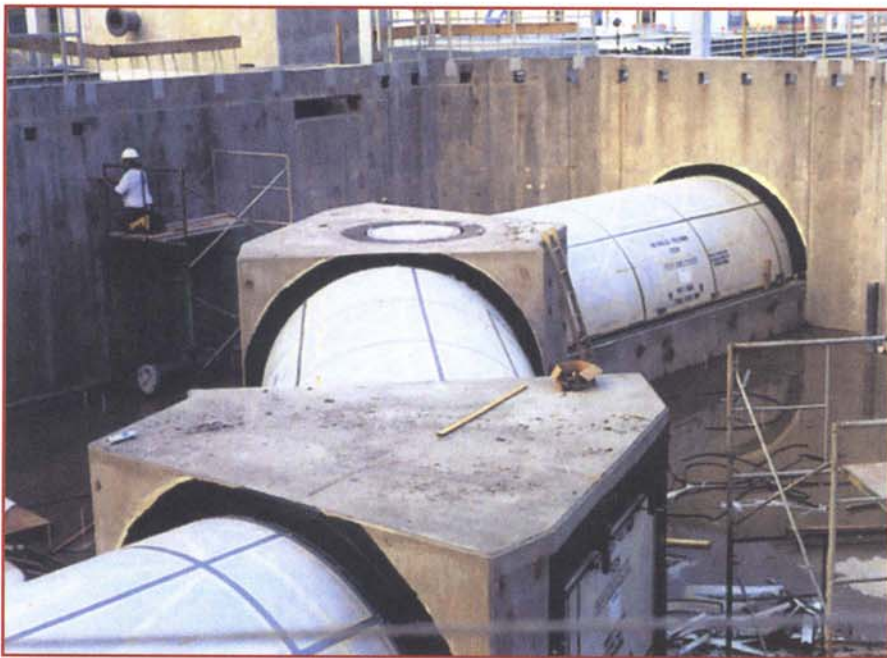
Figure 9 – One of the large marine tanks at Newport Aquarium during construction.

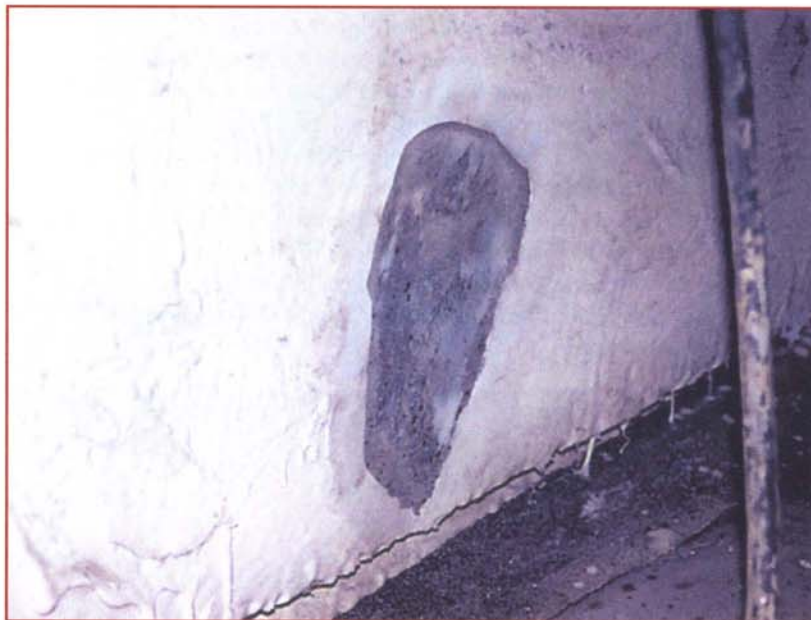
Figure 10 – Large blister at the base of a marine tank.

At the time of the first field visit, the waterproofing membrane had been removed from the tank floor. The majority of the blisters were reported to have occurred on the tank floor. Two blistered areas approximately 6 inches in diameter were also observed on the tank walls within 24 inches of the floor. No other blisters were observed on the tank walls, where the membrane had been left intact. Small delaminations in the membrane were observed at a limited number of locations. Subsequent conversations with the membrane manufacturer and research into the polyurea chemistry revealed that such deficiencies are likely due to reaction of isocyanates in the polyurea with moisture. This reaction results in formation of carbon dioxide that can cause small blisters to form within the membrane. This phenomenon is usually caused by improper mixing of the polyurea at the gun and can be alleviated through better mixing and application practices.

Based on the initial MVER measurements, it appeared that the blistering of the first membrane application in the first tank was due to high MVER through the floor of the tank. The high MVER was attributed to lack of an effective vapor retarder under the tank floor slab and flooding of the tank a few days prior to application of the membrane. These high moisture vapor emission rates were somewhat consistent throughout most of the tanks. At that time, the tanks were not protected from rain. Therefore, exposure to rain increased the moisture content of the slab resulting in a sustained high vapor emission rate.

1. Remove all laitance, oil, grease, and other surface contaminants from surfaces prior to installation of the system. Scarify surfaces by sandblasting or other techniques to produce a rough surface. It was recommended that the parge coat used to fill bugholes in the concrete be entirely removed from the concrete surfaces (but not from the bugholes) by sandblasting or other appropriate means. It was also recommended that the sandblasting provide a surface roughness similar to that of Test Area 1 or rougher. If surface preparation exposes additional bugholes, re-fill the bugholes and repeat surface preparation. After sandblasting, substrate surfaces should be cleaned carefully with

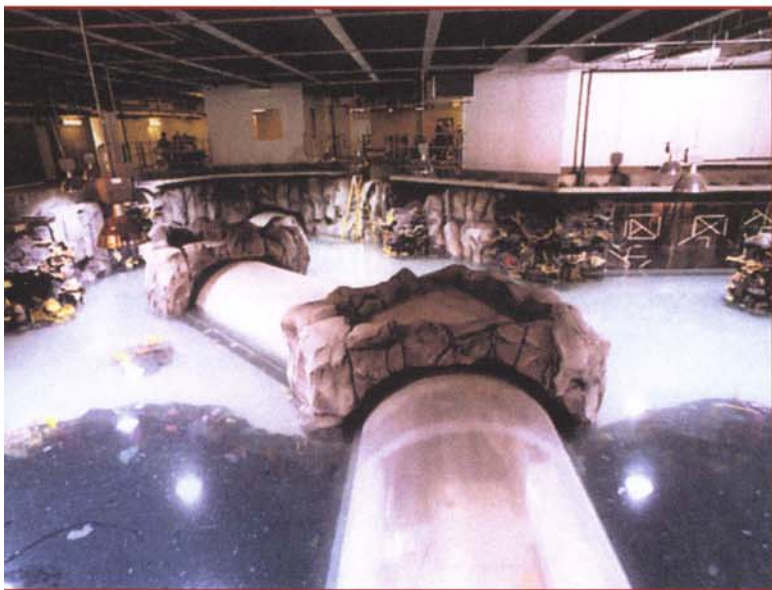
Figure 11 – A marine tank being filled with water.
