Project Name:
Fall Arrest Roof Anchor Installation

Project Location:
1120 North Lake Shore Drive
Chicago, Illinois

Nature of Services:
Evaluation, Design, Bidding Assistance,
Construction Phase Services

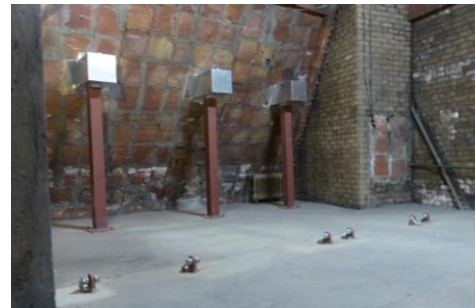
To address the unique layout of the east attic, BTC proposed installing 6 tieback anchors and structural steel stanchions with operable insulated enclosures within the attic space (lower right photo). The stanchions penetrate the copper gable roof of the attic, providing secure facade access along the building's east and west elevations.
