**Project Name:**  
Fall Arrest Roof Anchor Installation

**Project Location:**  
1120 North Lake Shore Drive  
Chicago, Illinois

**Nature of Services:**  
Evaluation, Design, Bidding Assistance,  
Construction Phase Services

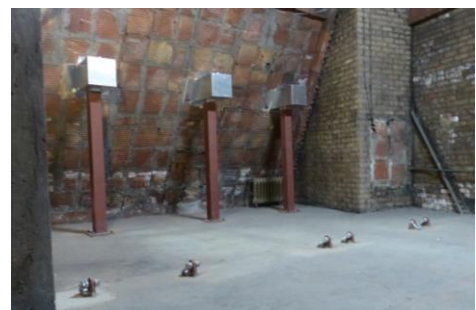
To address the unique layout of the east attic, BTC proposed installing 6 tieback anchors and structural steel stanchions with operable insulated enclosures within the attic space (lower right photo). The stanchions penetrate the copper gable roof of the attic, providing secure facade access along the building's east and west elevations.
